Manhole Inspection Summary

Manhole # S27G__008MH

Location Address: **864 W Fayette St** Cross Street: **S Poppleton St**

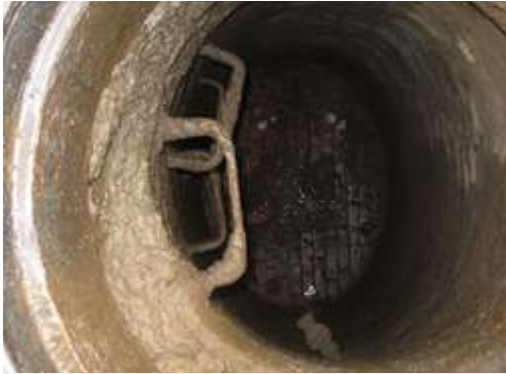
Defect 3

Frame Offset: **4** (in.) Condition: ☐ Sound ☐ Cracked ☒ **Leaks**

frame offset 4 inches

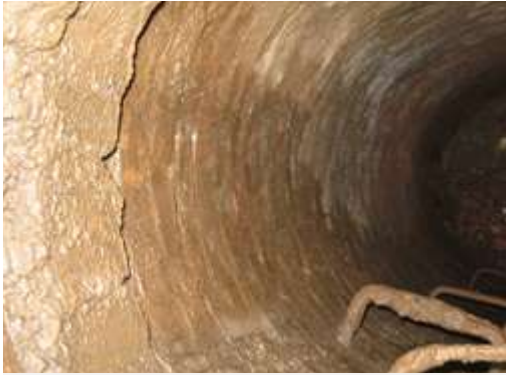
Defect 2

Chimney / Frame Adjustment ☒ Exists Material: **Brick** ☐ Parged Height: **7** (in.)
Condition: ☐ Sound ☐ Cracked ☐ Root Intrusion ☐ Loose Brick ☒ **Deteriorated**
Infiltration: ☐ None ☒ **Joint** ☐ Cracks ☒ **Mortar** ☐ Roots ☒ **Wall**

chimney cond deteriorated, chimney joint infiltration, mortar, chimney flow wall

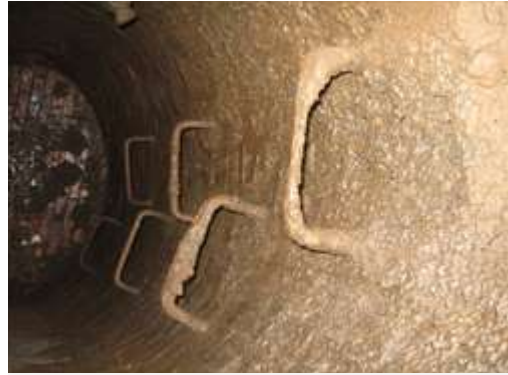
Defect 1

Barrel Material: **Brick** ☐ Parged
Shape: **Circular** Diameter: **34** (in.) Length: **0** (in.)
Condition: ☐ Sound ☐ Cracked ☐ Root Intrusion ☐ Loose Brick ☒ **Deteriorated**
Infiltration: ☐ None ☐ Joint ☐ Cracks ☐ Mortar ☐ Roots ☒ **Wall**

Steps Count: **6** Missing: **0** ☒ **Corroded**

corroded steps, barrel infiltration wall, barrel cond deteriorated

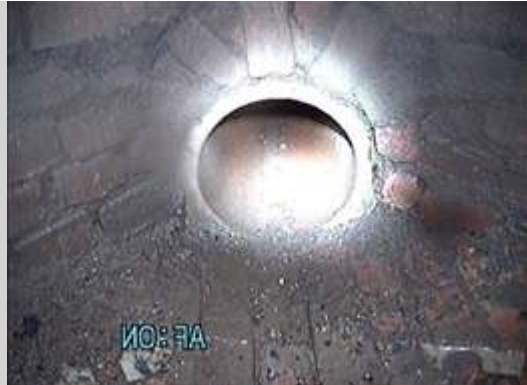
12 O'Clock Outflow

8 in. Circular Gravity Sewer
Pipe Out @ 12 O'Clock

Pipe Height: **8.4** (in.) Rod and Bar (Angled)
Pipe Material: **Clay** ☐ Pipe Lined
Invert Depth: **10.08** (ft.) Flow Characteristics: **None**
Deposits: ☒ None ☐ Mud ☐ Sludge ☐ Debris ☐ Grease
Silt Depth: **0** (in.) Deposits Extent:
Infiltration: **Evidence** Pipe Seal Cond: **Unknown**

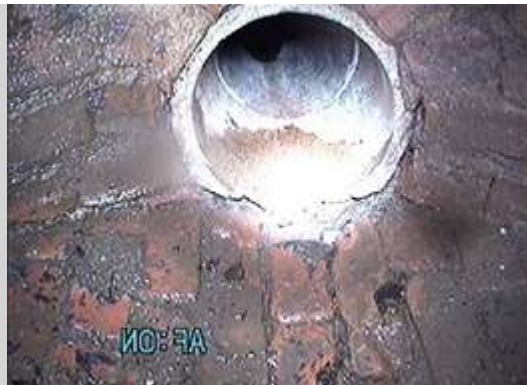
6 O'Clock Outflow

8 in. Circular Gravity Sewer
Pipe In @ 6 O'Clock

Pipe Height: **8.4** (in.) Rod and Bar (Angled)
Pipe Material: **Clay** ☐ Pipe Lined
Invert Depth: **9.75** (ft.) Flow Characteristics: **None**
Deposits: ☒ None ☐ Mud ☐ Sludge ☐ Debris ☐ Grease
Silt Depth: **0** (in.) Deposits Extent:
Infiltration: **Evidence** Pipe Seal Cond: **Unknown**
